Report: Sample report 01-16

INSPECTION REPORT

DATE OF INSPECTION: 01-08-2016.
CLIENT NAME: John Doe Jr.
ST. ADDRESS: Any street.
CITY, STATE, ZIP: Anywhere in central Fl.
OCCUPIED: No.
DISCLOSURE:

AGE: 29 yrs.
STRUCTURE TYPE: Single Family home.
STORIES: 1
FOUNDATION: Slab on grade.

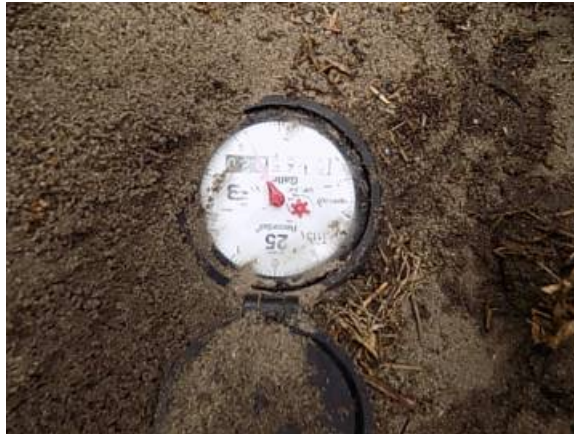
WATER SOURCE: Public utility. Meter is located in rear NE corner. Flow dial or indicator is not turning or showing flow when viewed. This is an indication that NO significant leakage is present in main or supply lines at time of inspection.

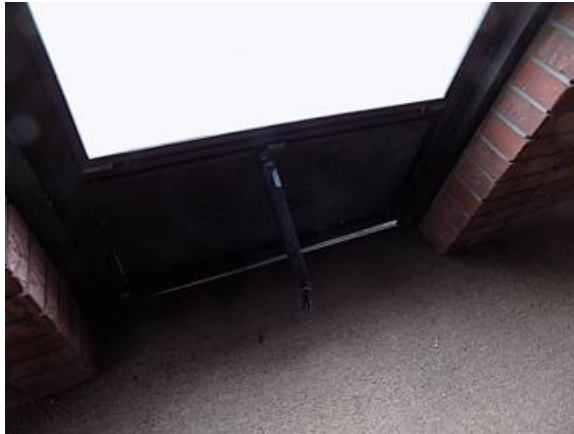
TYPE: Concrete slab.
CONDITION: No problems noted at time of inspection.
POOL/ PORCH ENCLOSURE: Aluminum framed, window enclosed.
CONDITION: Overall condition is good.
 Door closure needs repair.

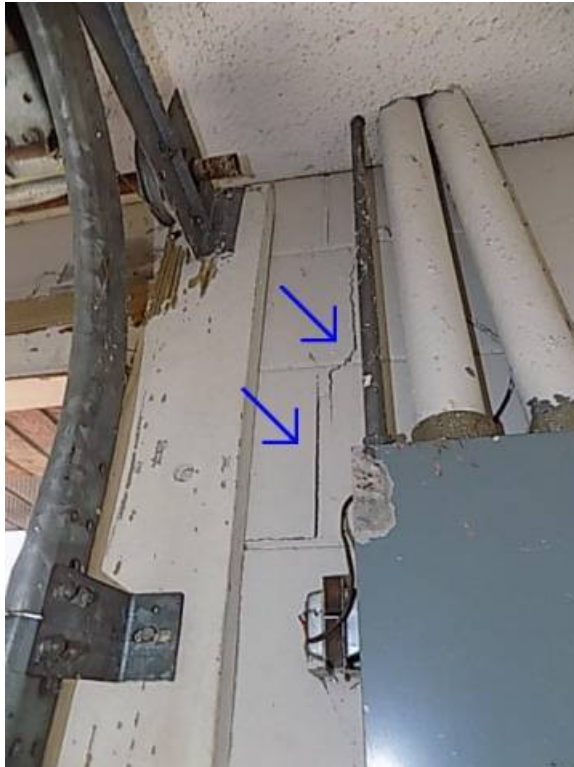
Settling cracks seen in some areas around perimeter.

A larger crack is noted on right side of garage door lintel. Recommend further inspection by a qualified person in this field.

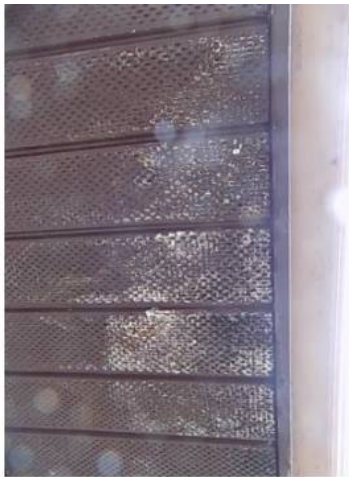
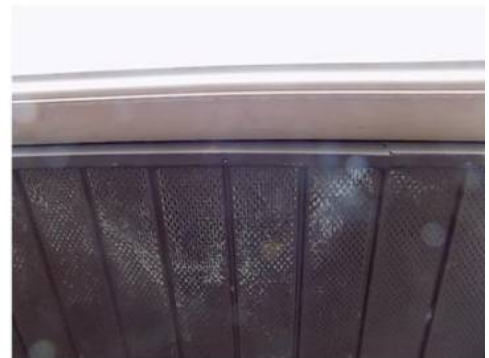
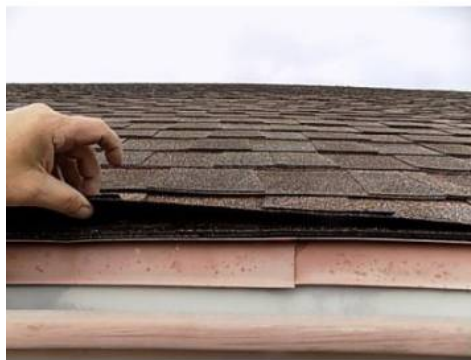
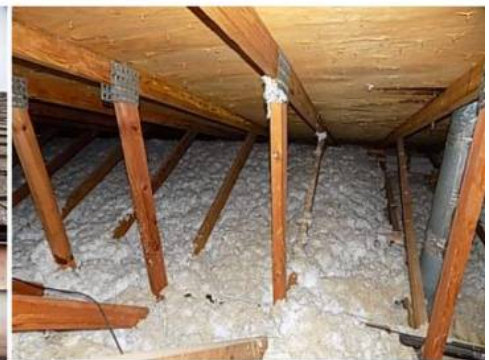
STYLE: Hip.
ROOF ACCESS: Walked.
ROOF COVERING: Composition shingle, Architectural style.
ROOF COVERING STATUS: There appears to be two sets of shingles installed on roof.
Active leakage is present on front and rear overhangs.
Repair and further inspection of entire roof covering by a licensed roofer is advised.

TYPE: Combination of materials used; Sheet metal and Lead plumbing vent boots.
CONDITION: Roof appears to be leaking around drip edges on front and rear of home.

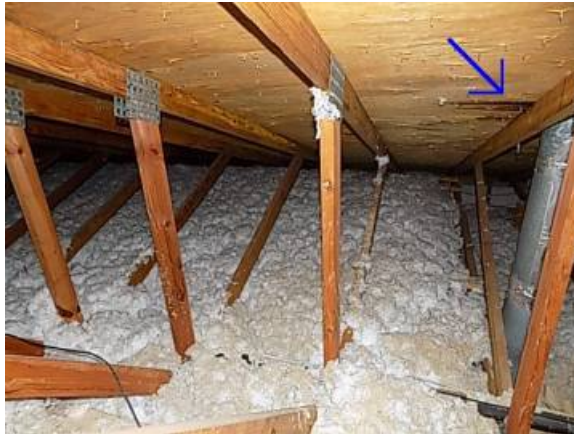
ACCESS : Pull down ladder.
ROOF FRAMING: Engineered trusses.
CONDITION: No visible problems seen at time of inspection.
ROOF SHEATHING: Plywood.
CONDITION: Sign of past or present leakage seen.
Further evaluation and repair is recommended by a qualified person that specializes in this trade or field of construction

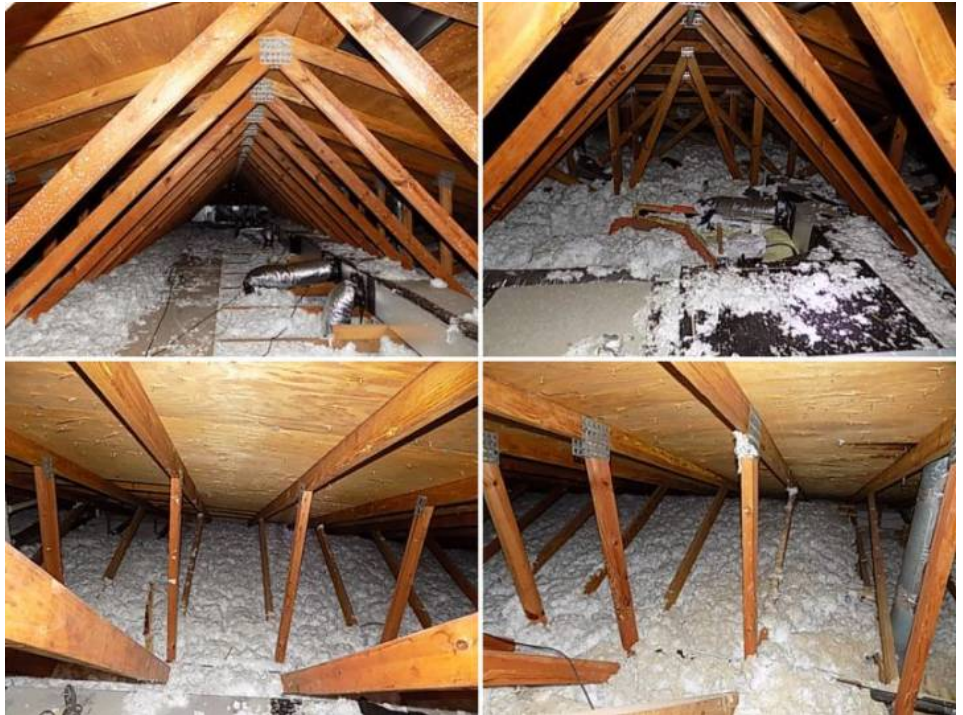
CONDITION: Insulation has compacted over time and a true "R" value is no longer achieved.
TIP: Recommend you contact your local Electrical Utility Company to find out if they perform FREE energy audits. After having their inspections they will typically provide incentives, if they determine that you need them in the form of vouchers for upgrading conditions in your home that cause you use excessive power consumption. These programs are not limited to insulation only. Some include upgrading windows, weather stripping, water heaters and appliances including Heat and Air system.

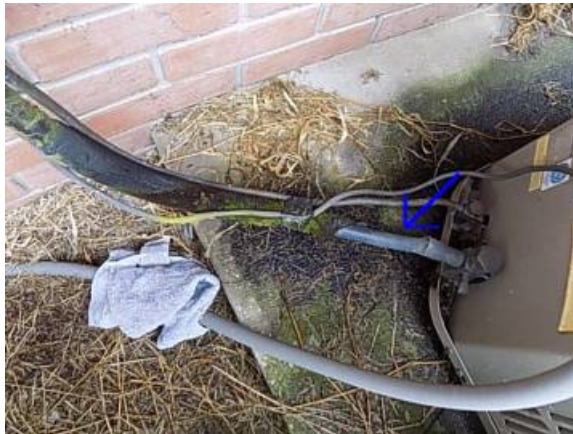
- SYSTEM TYPE:* Heat pump with supplement heat strips.
- FUEL TYPE:* Electric.
- POWER SOURCE:* 240 Volt.
- SERVICE DISCONNECT:* Disconnect present.
- ESTIMATED CAPACITY:* 4 Ton / 48000 BTU.
- ESTIMATED AGE:* 13 yrs.
- EXTERIOR UNIT:* Insulation is missing or deteriorated on refrigerant lines. Replacing is recommended.

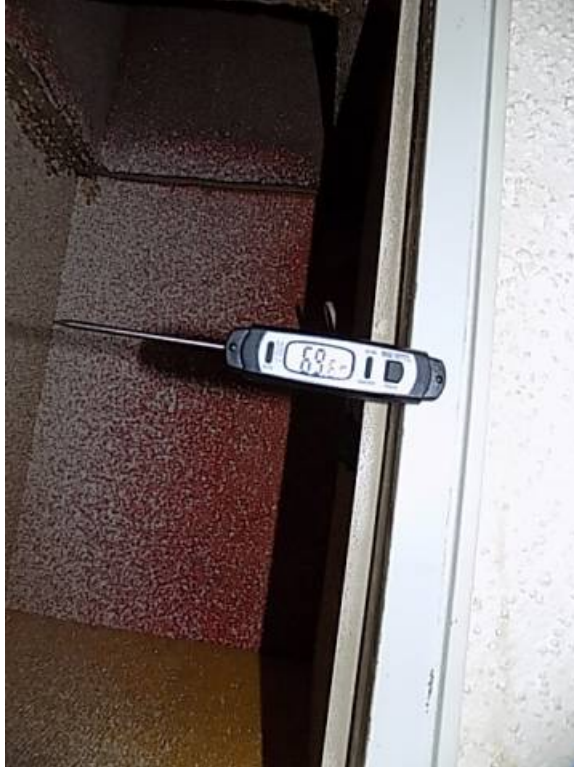
Dirty / restricting air flow across coils.
 Unit responded to normal controls. Thermostats are not tested for calibration.
 74.5.

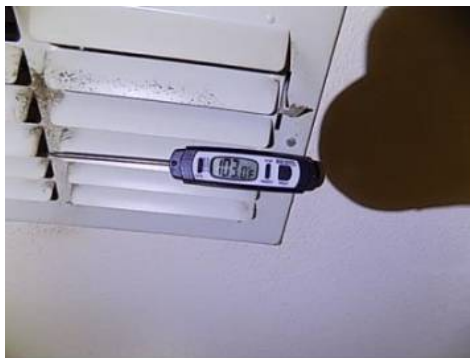
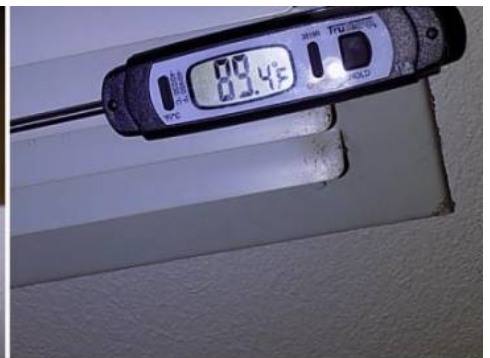
Heat pump mode. 103.0
 Supplemental heat mode. 89.4.

Heat Pump mode. 28.5
 Supplemental heat mode. 14.9.

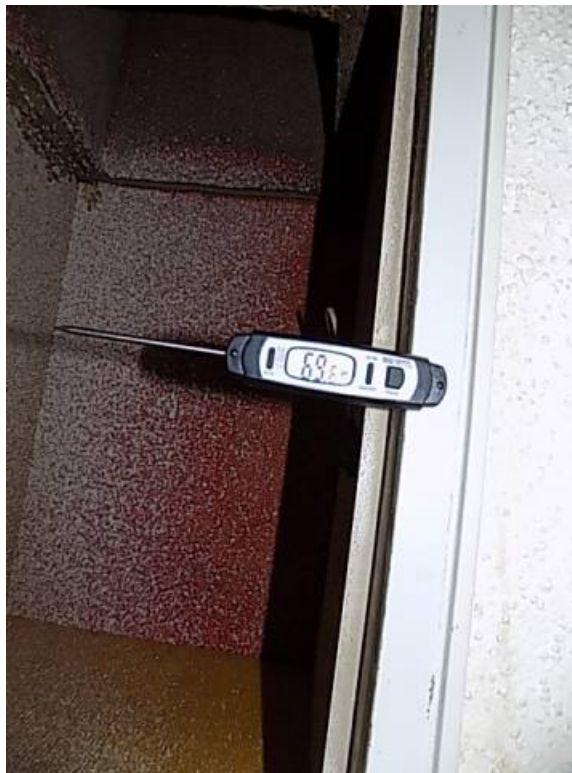
AIR FILTERS: See note concerning filter above.
CONTROLS: See note concerning thermostat above.
RETURN TEMPERATURE in F: 69.8.

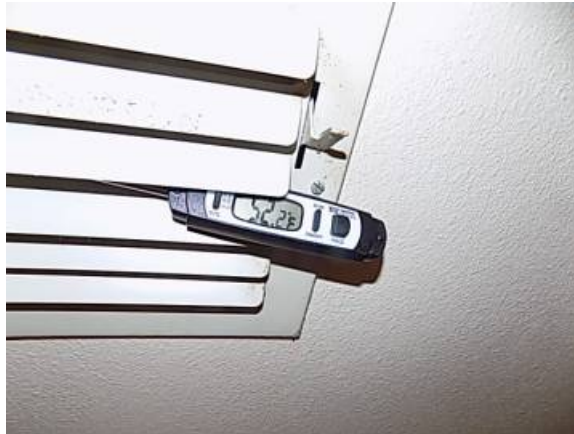
SUPPLY TEMPERATURE in F: 52.2.

17.6 / Typical air drop is between 14-20 degrees. This is based on a working temperature of between 75 and 95 degrees.

Lower ambient temperature is giving a higher than normal air drop

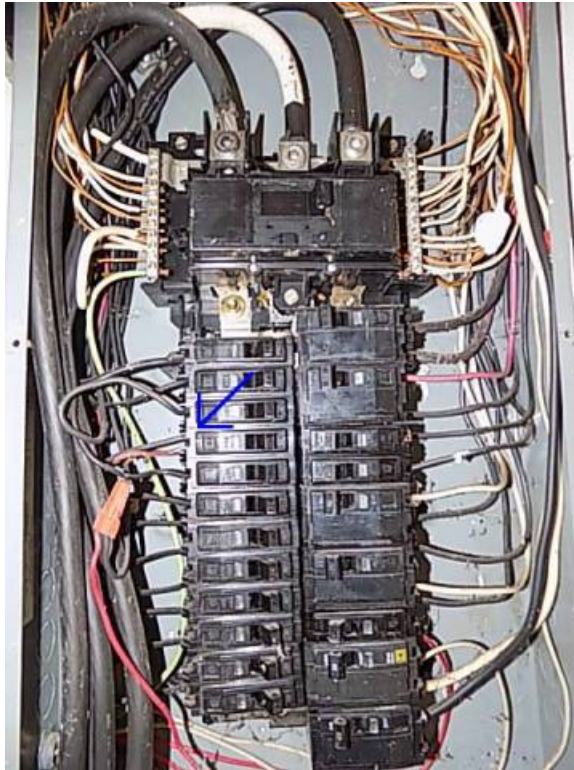
Over current protection and wire sizing is correct so far as visible.
Double tap seen on one breakers. This is a potential hazard and not acceptable to several Insurance Underwriting companies.

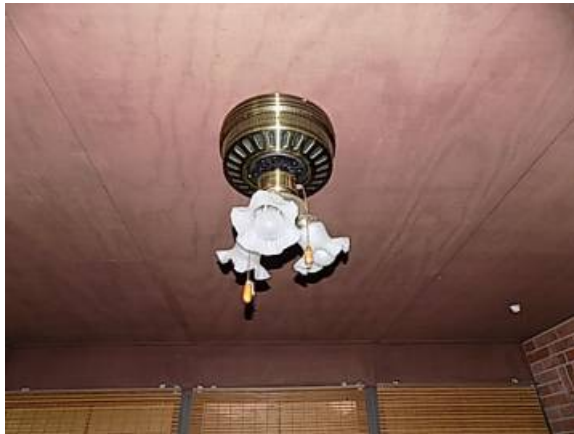
NOTE: fan on rear porch is missing blades. Fan in dining area has a loose light fixture.

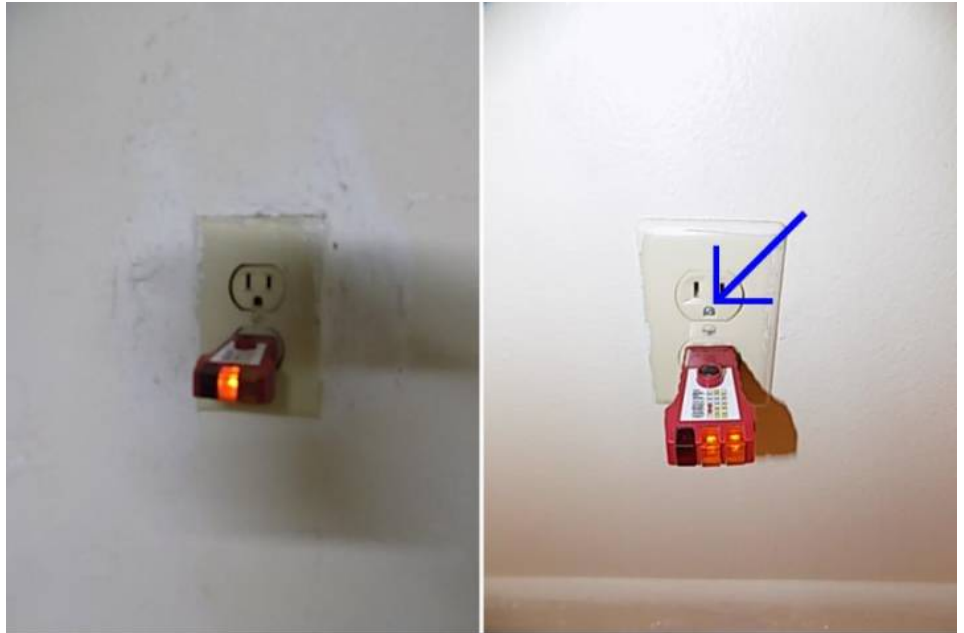
NOTE: one receptacle located in garage has an open ground and one receptacle front bedroom has a ground plug broken off inside.

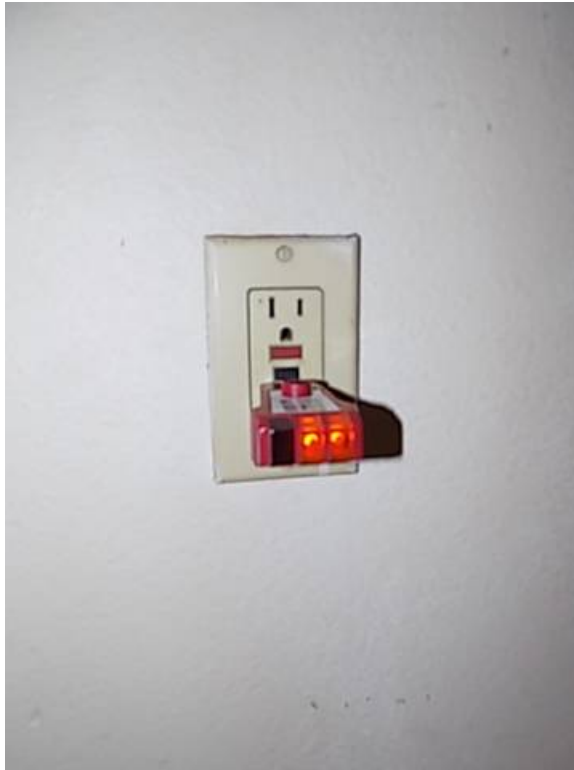
One GFCI receptacle located in garage did not responded to test button.
Ground Fault Circuit Interrupter (GFCI) protected outlets are not installed in all locations. These are recommended safety features, due to their proximity to water.
They are recommended on exterior, garage, bath rooms, laundry & kitchen receptacles.

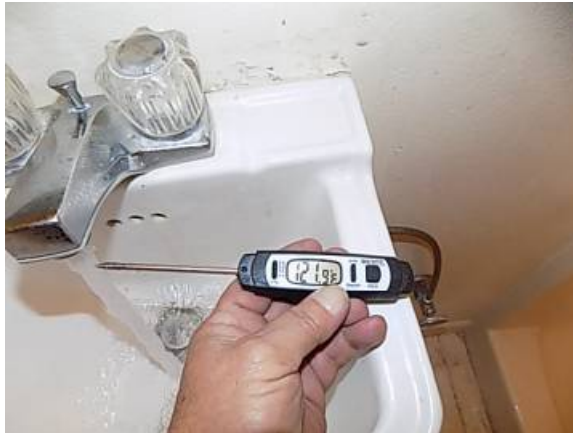
LOCATION: Garage.
TYPE: Electric.
SIZE: 40 US Gallons.
TPR VALVE: Installed with drain line.
TEMPERATURE 121.9.

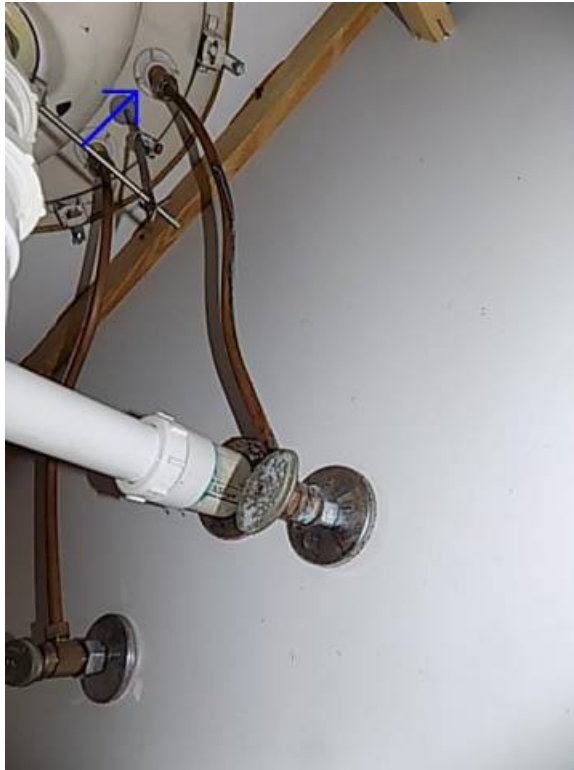
BATH LOCATION: Hallway.
VANITIES(s) No visible problems seen.
SINKS(s) / FIXTURE(s): Faucets are leaking on underside of sink. Repair or replacing needed.

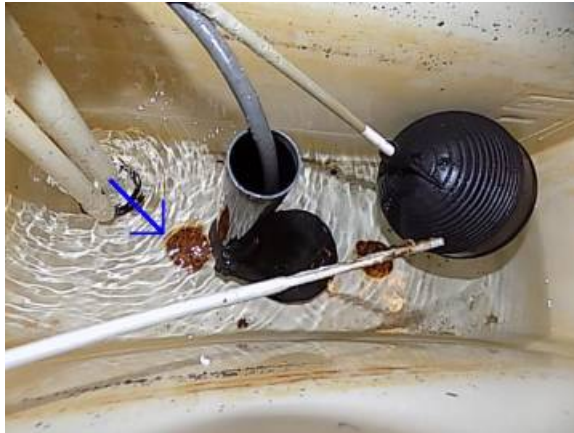
Tank screws have severe corrosion, this is a leak potential, repairs are needed.

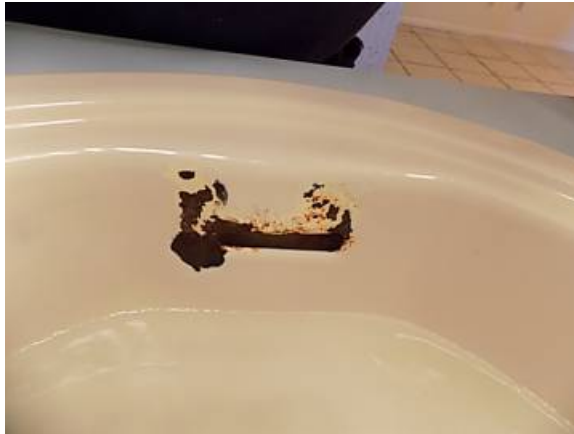
Outside sink is deteriorated and needs replacing.

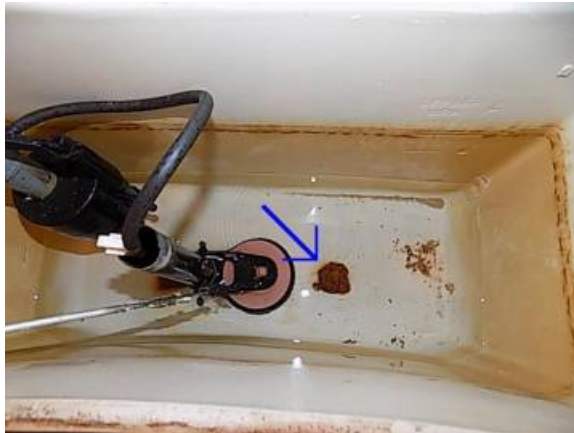
TOILET: Tank screws have severe corrosion, this is a leak potential, repairs are needed.

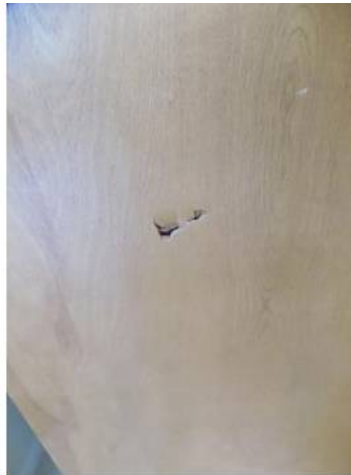
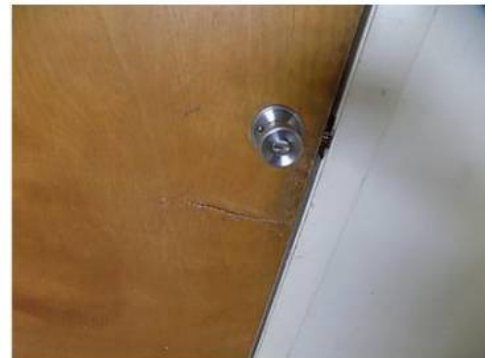
MAIN ENTRY DOOR: No problems seen.
DOOR CHIME: Operational.
EXTERIOR DOORS: Sliding glass.
CONDITION: No problems seen.
INTERIOR DOORS: Overall condition is good. Two have some damage.
